Manhole Inspection Summary

Manhole # S41A__011MH

Insp Date: **11/14/08 12:18 PM**

Location Address: **1235 treelef ct**

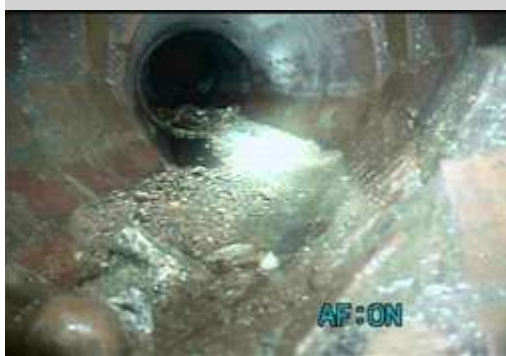
MISC

channel debris

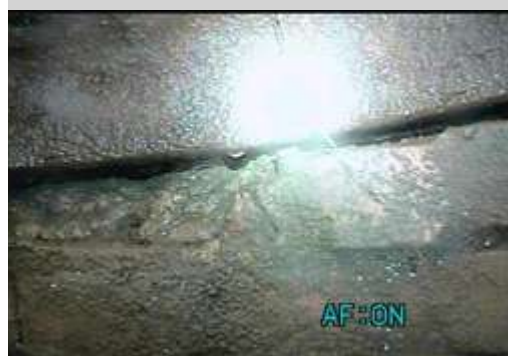
Defect 2

Condition: ☐ Sound ☒ **Cracked** ☐ Root Intrusion ☒ **Loose Brick** ☒ **Deteriorated**

chimney cracked loose bricks deteriorated at frame joint

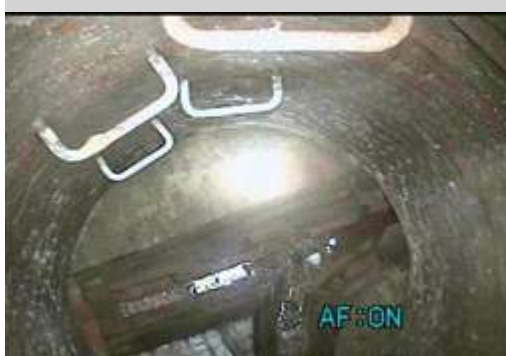
Defect 1

Count: **4** Missing: **0** ☒ **Corroded**

steps corroded

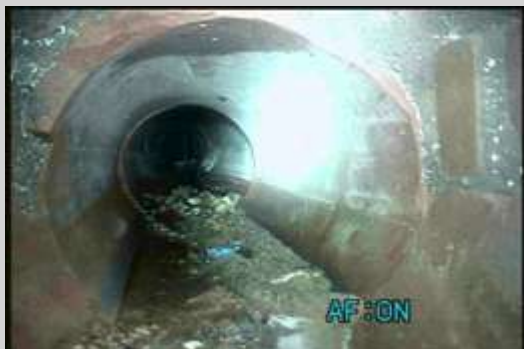
3 O'Clock Inflow

Deposits: ☐ None ☐ Mud ☒ **Sludge** ☐ Debris ☐ Grease

Silt Depth: 3 (in.) Deposits Extent: **Light**
